Manhole Inspection Summary

Manhole # S31II_026MH

Location Address: **121 MCMECHEN ST**

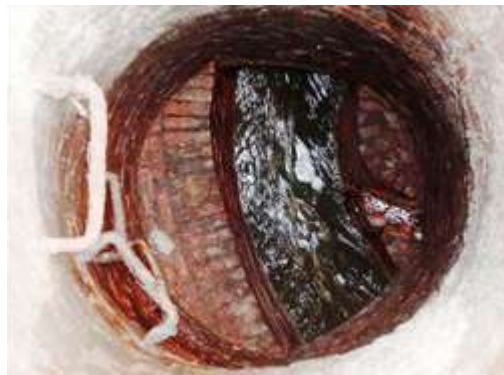
Top View

Corroded steps. Evidence of surcharge - Bench debris.

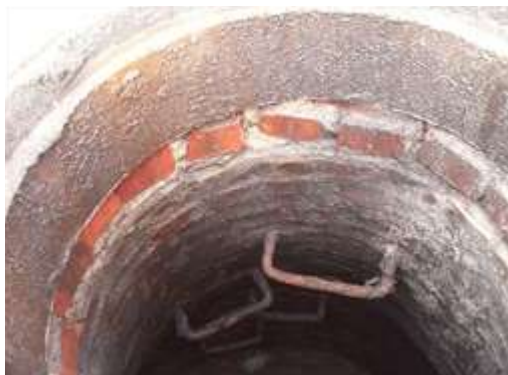
Defect

Frame leaks. Adjustment deterioration and infiltration. Corbel and Barrel infiltration - other side.

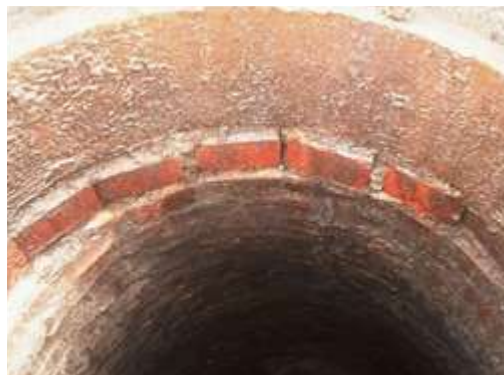
Defect

Frame leaks. Adjustment deterioration and infiltration. Corbel and Barrel infiltration.

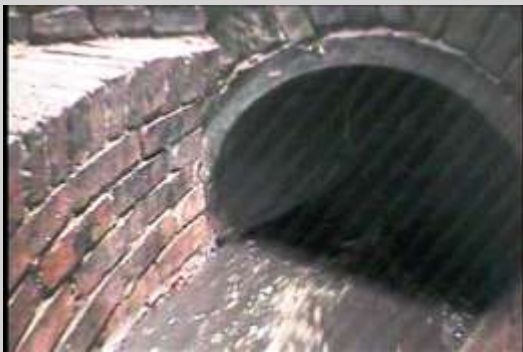
24 in. Circular Gravity Sewer Pipe Out @ 12 O'Clock

Channel deterioration.

Infiltration: **Evidence** Pipe Seal Cond: **Unknown**

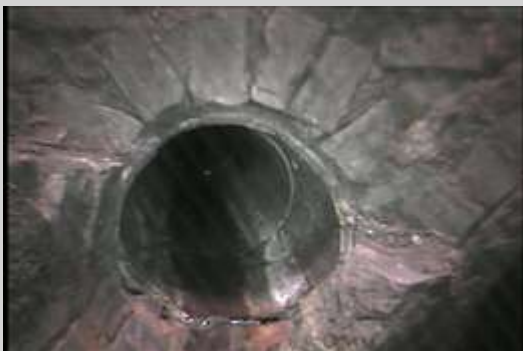
8 in. Circular Gravity Sewer Pipe In @ 3 O'Clock

Infiltration: **Evidence** Pipe Seal Cond: **Unknown**

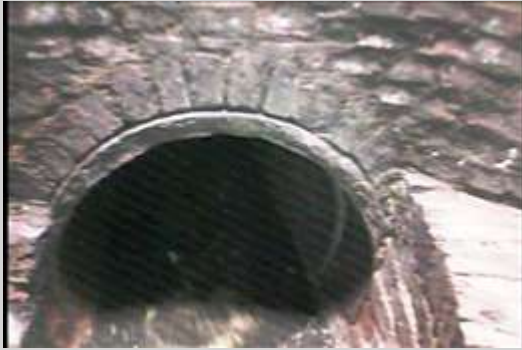
24 in. Circular Gravity Sewer

Deposits: ☐ None ☒ **Mud** ☐ Sludge ☒ **Debris** ☐ Grease

Silt Depth: **0.5** (in.)

Deposits Extent: **Light**
